# Final Report

## Design Verification and CEDRIG Analysis Study

**Small Irrigation Programme,**  
Programme Management and Implementation  
Support Consultant,  
Biratnagar

String Engineering (P) Ltd.

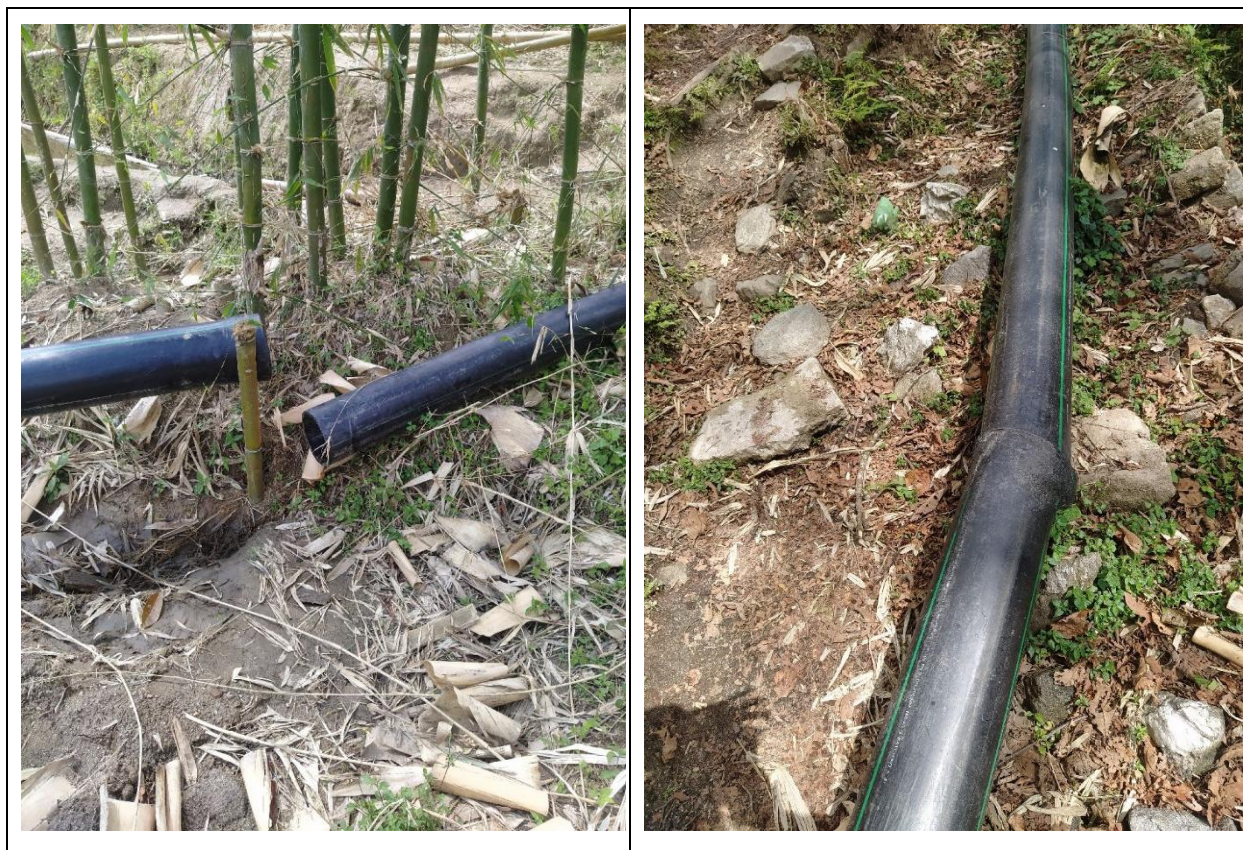
HDPE pipes have been used in schemes where pipes have been used in part of the conveyance. For HDPE pipes, the connections between pipes need to be done with butt welding with fusion of the pipe ends by heating plate and pressing against end to end once the ends are heated and melted to required degree. However, farmers chose to heat one end of the pipe to expand it and insert other pipe to make a kind of socket joint which is not standard procedure for HDPE joint. Such a joint is likely to come apart as the water flows through the pipes and pressure is developed. For proper butt welding, heating plates are needed. Generators are needed for electrical heating in remote locations where electricity is not accessible. Farmers were not provided with this equipment for connection of the pipes neither were they trained properly. It is recommended that for future implementation, full set of electrical heating plates with generators be procured and kept either in the cluster office or provided to the local governments so that farmers can borrow them for construction and return once the job is done.

Photo 3-1: Examples of weak pipe joint a) Jaljale Chuchhe Dhuna Dobela IS, Khotang and b) Kharuwa khola Nali pipal danda rajkulo IS, Khotang.

Proper anchoring of the pipes is necessary where pipe conveyance has been used. Due to lack of anchoring of the pipes especially at joints, pipe joints have failed in some cases.

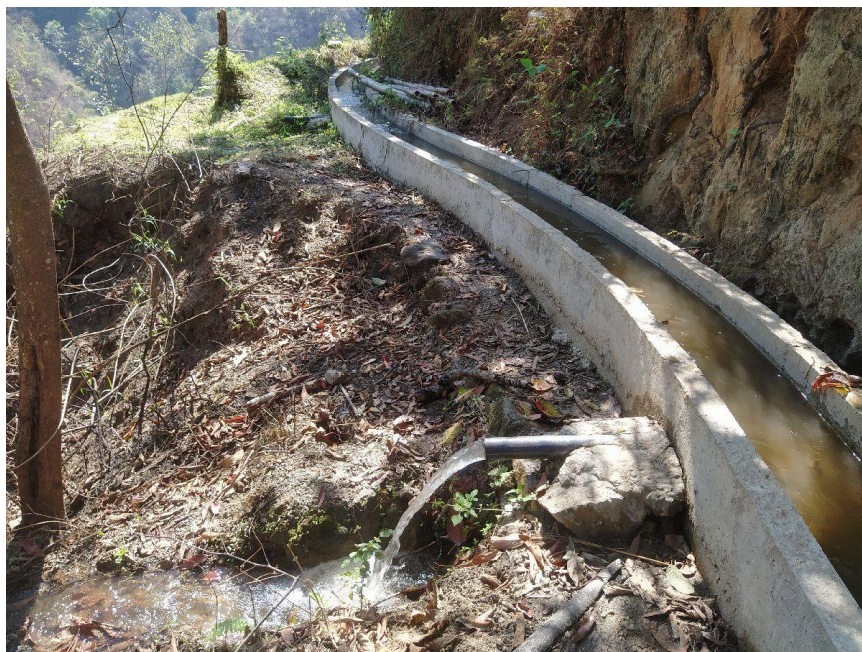
Photo 3-2: Release of water from outlet to slopes without proper protection in Khiku Khola Lamkulo IS, Khotang.

The outlets are designed as pipe outlets embedded in the concrete lining which discharge out water in the open field. In hill schemes, discharge from the outlets have been released in the slopes without any structures. This has made the slopes more vulnerable as the open release of water may trigger landslide or erosion of the slopes. A properly designed outlet with proper release of the water is necessary. It is clarified by PMISC that they have improved the design of the outlets in recent years.

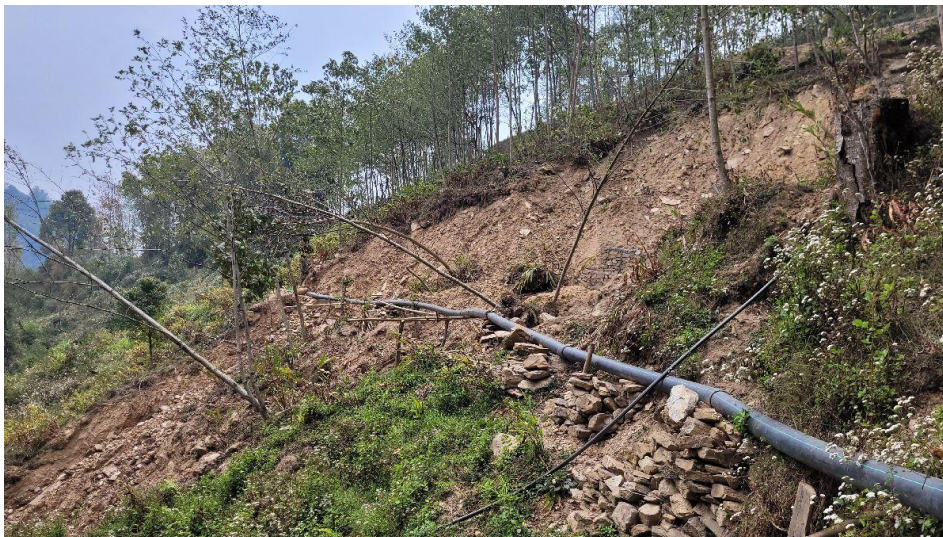
*Photo 3-3: Pipe exposed to landslide and in vulnerable condition in Siran Kulo IS, Bhojpur.*

There is problem of landslide in the initial reach of the alignment. Pipe has already been damaged by the landslide and repair has been done. The construction of road near the pipe alignment has also triggered the landslide.

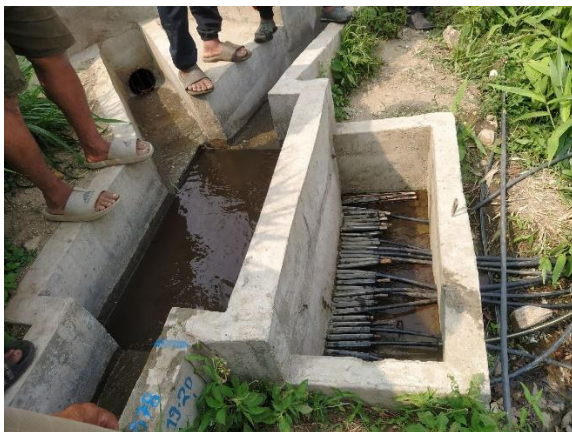
*Photo 3-4: Individual farmers using small pipes for sprinkler irrigation, needs appropriate design for distribution pipes for sprinklers.*

- Users requested piped distribution system in command area to be able to use sprinkler systems in some of the cases.

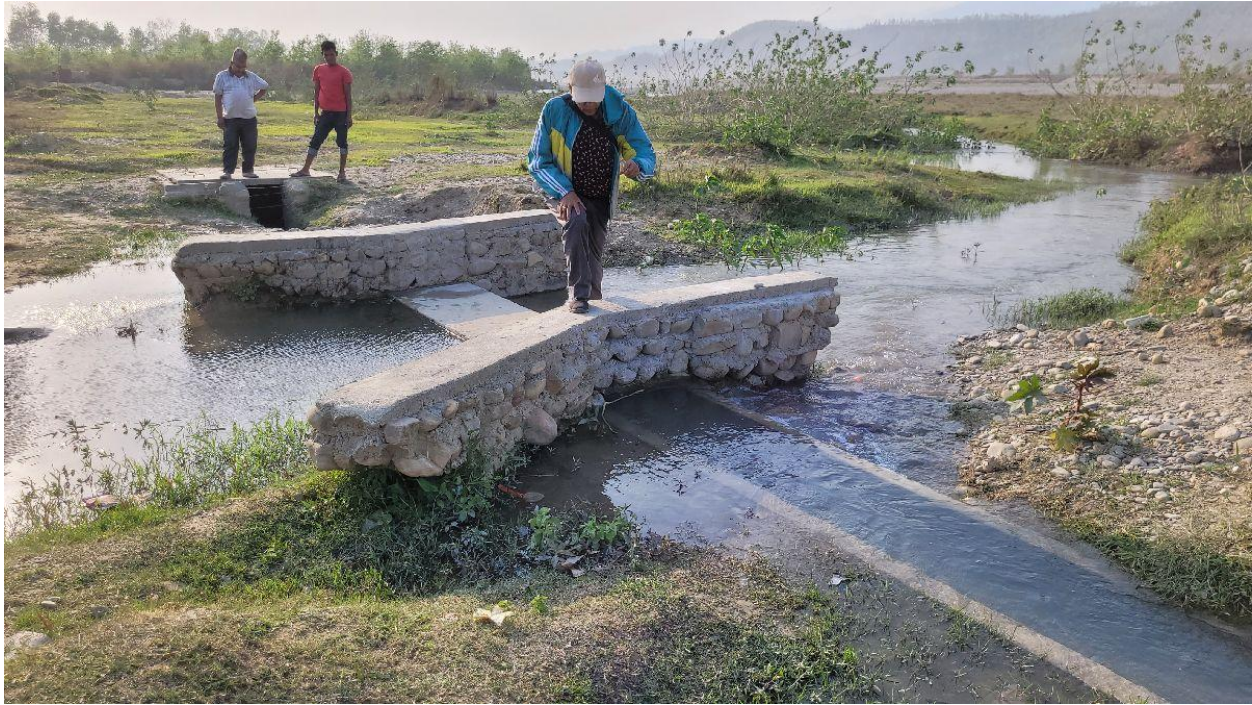
There is a risk of flooding and bank erosion of agricultural land. There is also a risk of washing away of side intake, link canal and river crossing structures. There was a big flood in the river in 2077 BS due to damming up of the river in the watershed following the landslide triggered by the heavy rainfall, and bursting of the

*Annex Photo 1: River crossing structure in Hadaiya Sana Sinchai Aayojana IS.*

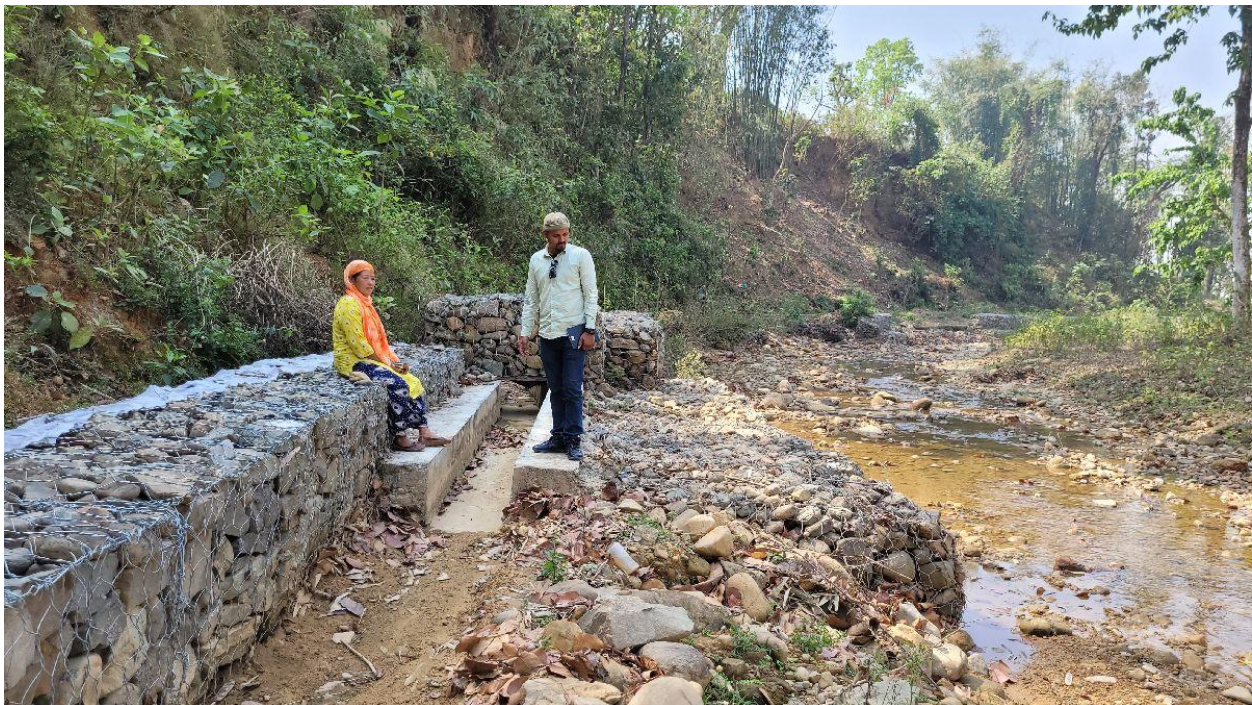
There is a likelihood of soil being unstable and landslide in the head reach of the canal. However, this is not disrupting the canal at the moment.

Annex Photo 2: Intake of Pahare Kulo Tin Dobhane Muni IS.

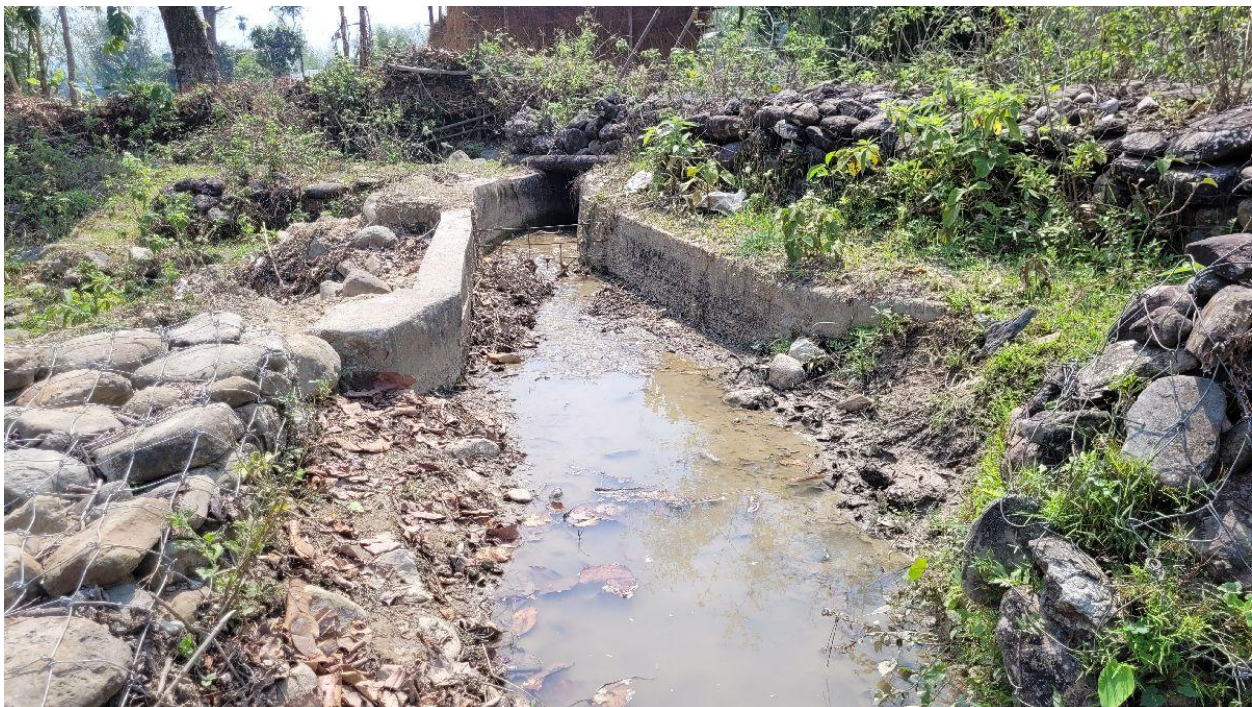
*Annex Photo 3: Intake of Katari Sinchai Yojana IS.*

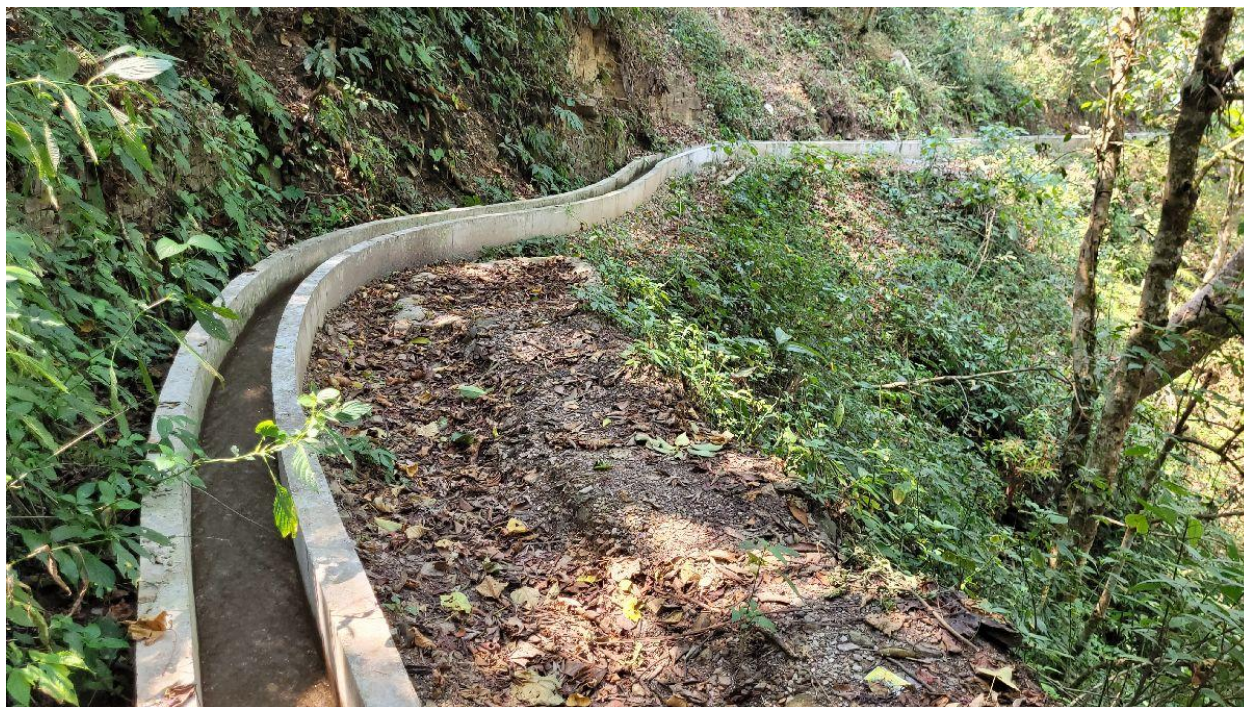
There is problem of landslide along the canal alignment. The source has not completely dried and the users have noticed only 10 to 20% variation in the lowest water flow.

*Annex Photo 4: Canal RCC lining in Pakhale Khola Dhonde IS.*

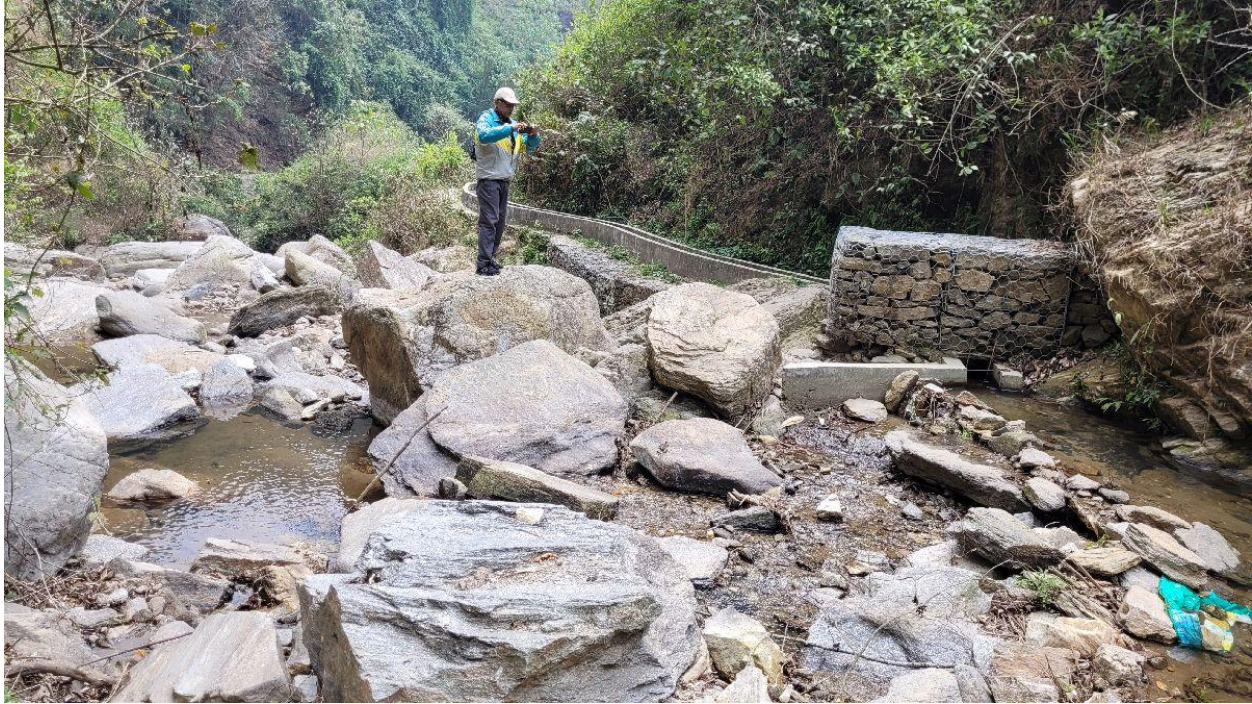
*Annex Photo 5: Intake of Siran Kulo IS, Bhojpur.*

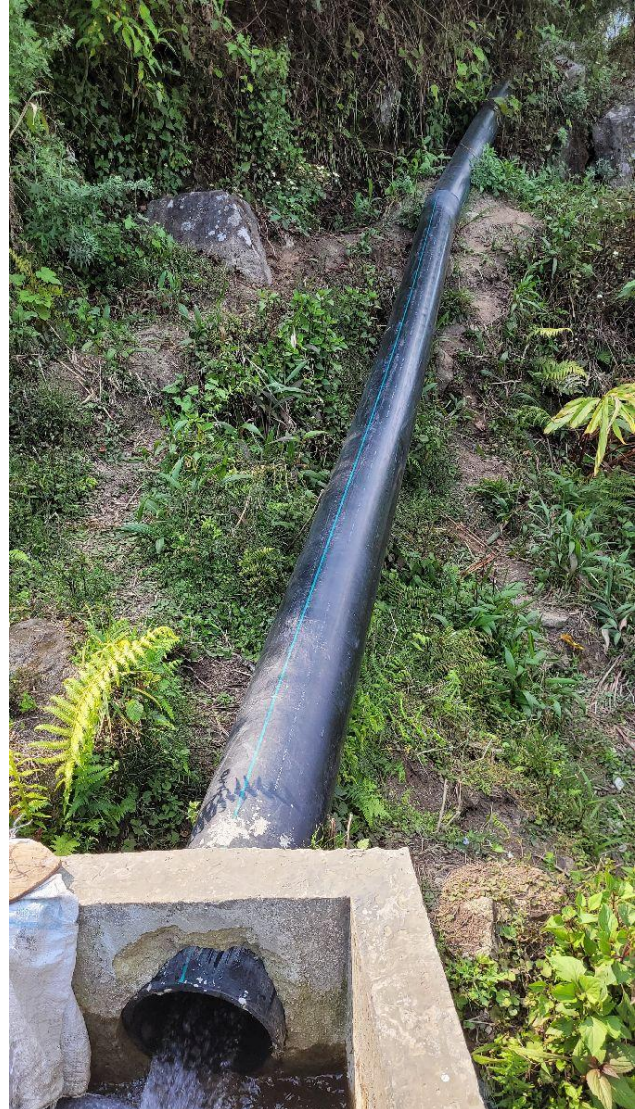
It is found that the joints in the pipes are not done in standard manner. For HDPE pipes butt welding is required with heating the end of the pipes and pressing against each other for fusion. It is noticed that the farmers were not provided with and lack the necessary equipment which are electrical heating plates, jacks and generator to carry out the joint in the pipes properly. So, they carried out joining heating one pipe and inserting the other into the heated pipe. This joint is not standard and is likely to fail with water pressure. The pipes need to be buried into the soil to avoid external impact to the pipes. However, the pipes have been installed open on the ground exposing it to the outside disturbances which is likely to cause damage of the pipes.

*Annex Photo 6: Pipe conveyance in Taname IS, Tehrathum.*

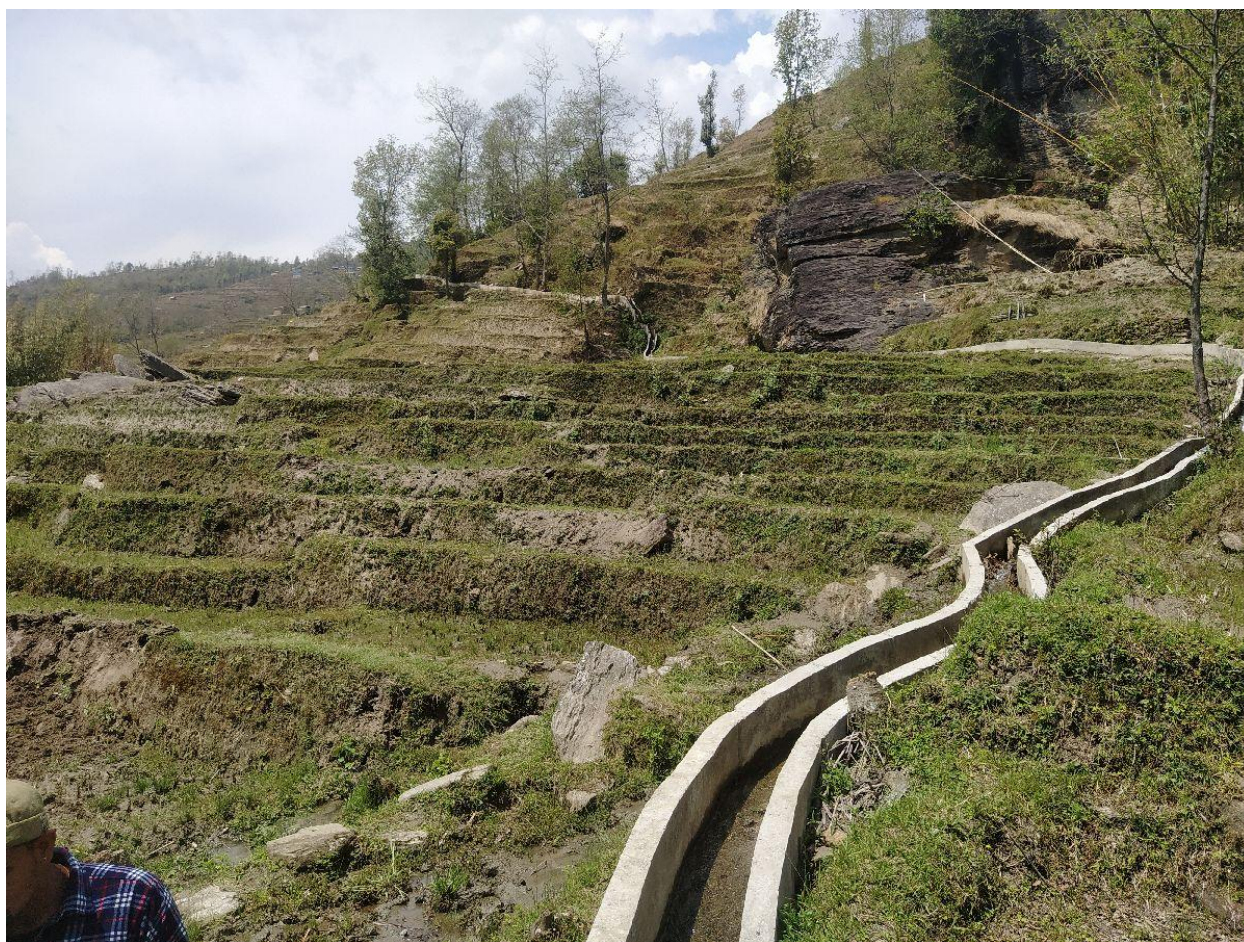
There is problem of land subsidence in the middle part of the canal alignment which has created minor crack in the canal lining and it might affect the canal lining in the long run if the land subsidence does not stop. There is problem of landslide along the canal alignment.

*Annex Photo 7: Canal lining and command area of Jaljale Chuchhe Dhuna Dobela IS in Khotang District.*

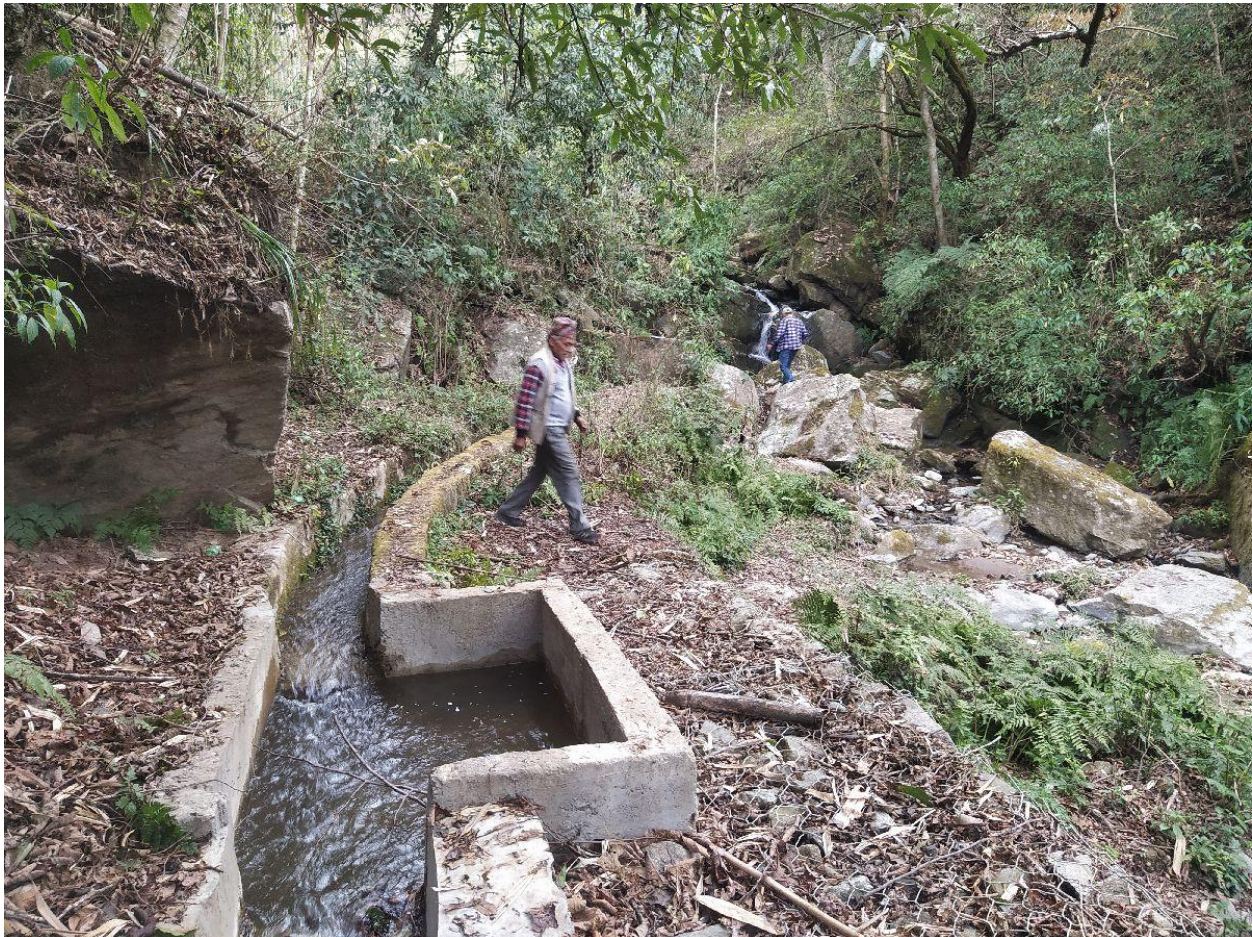
Annex Photo 8: Intake of Kharuwa khola Nali pipal danda rajkulo IS, Khotang.

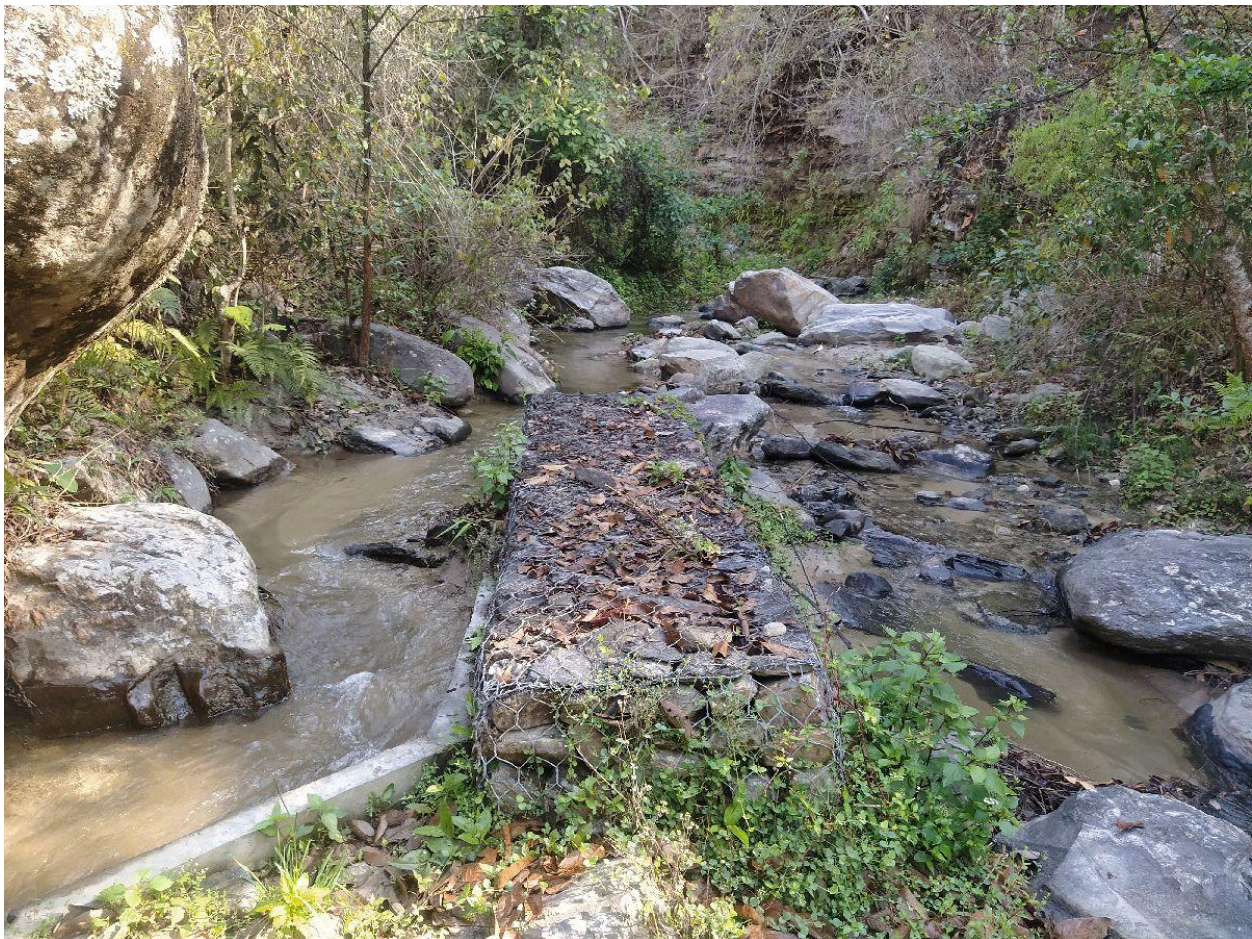
*Annex Photo 9: Intake of Khiku Khola Lamkulo IS in Khotand District.*

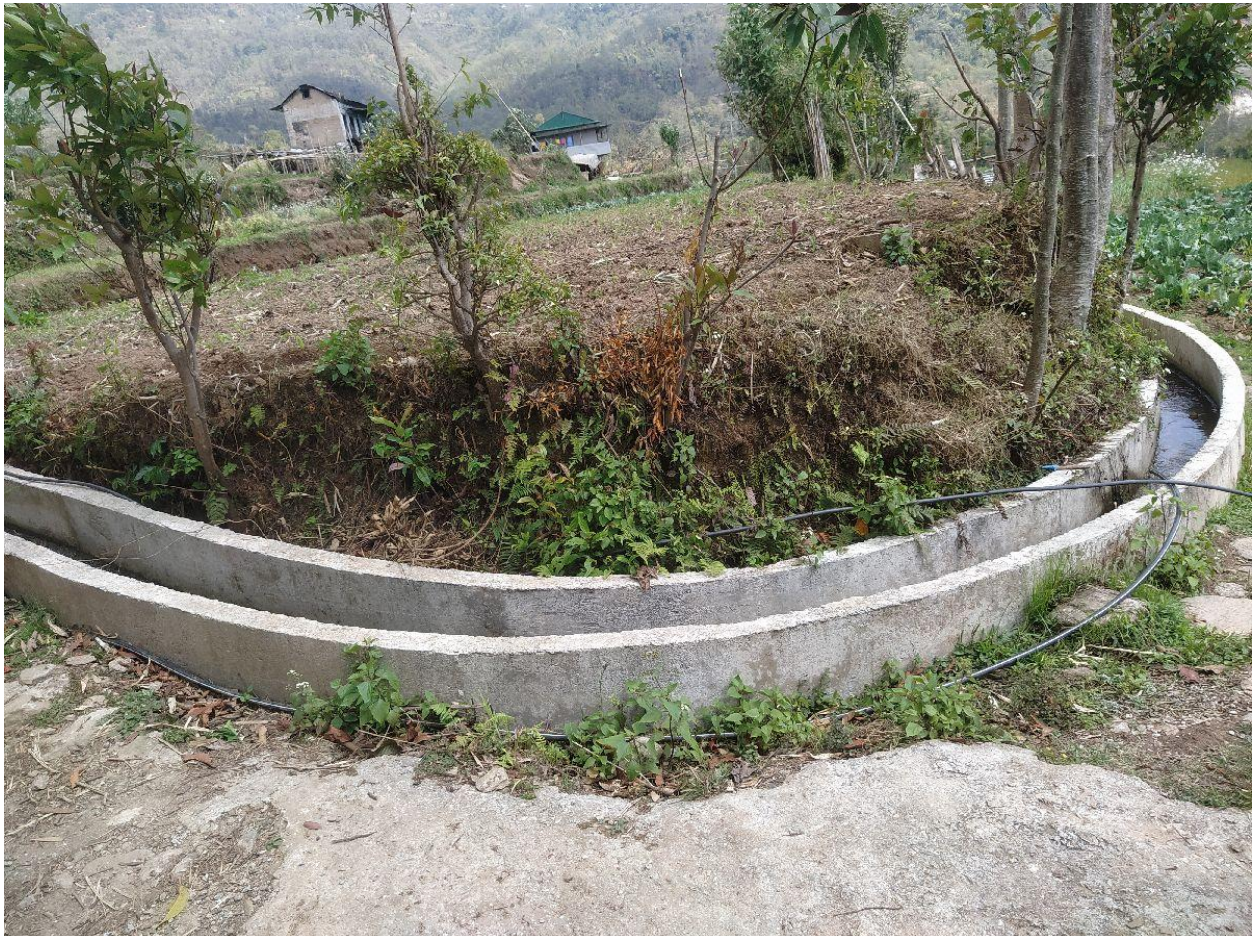
*Annex Photo 10: Canal lining in Argeli Taksar IS in Okhaldhunga.*

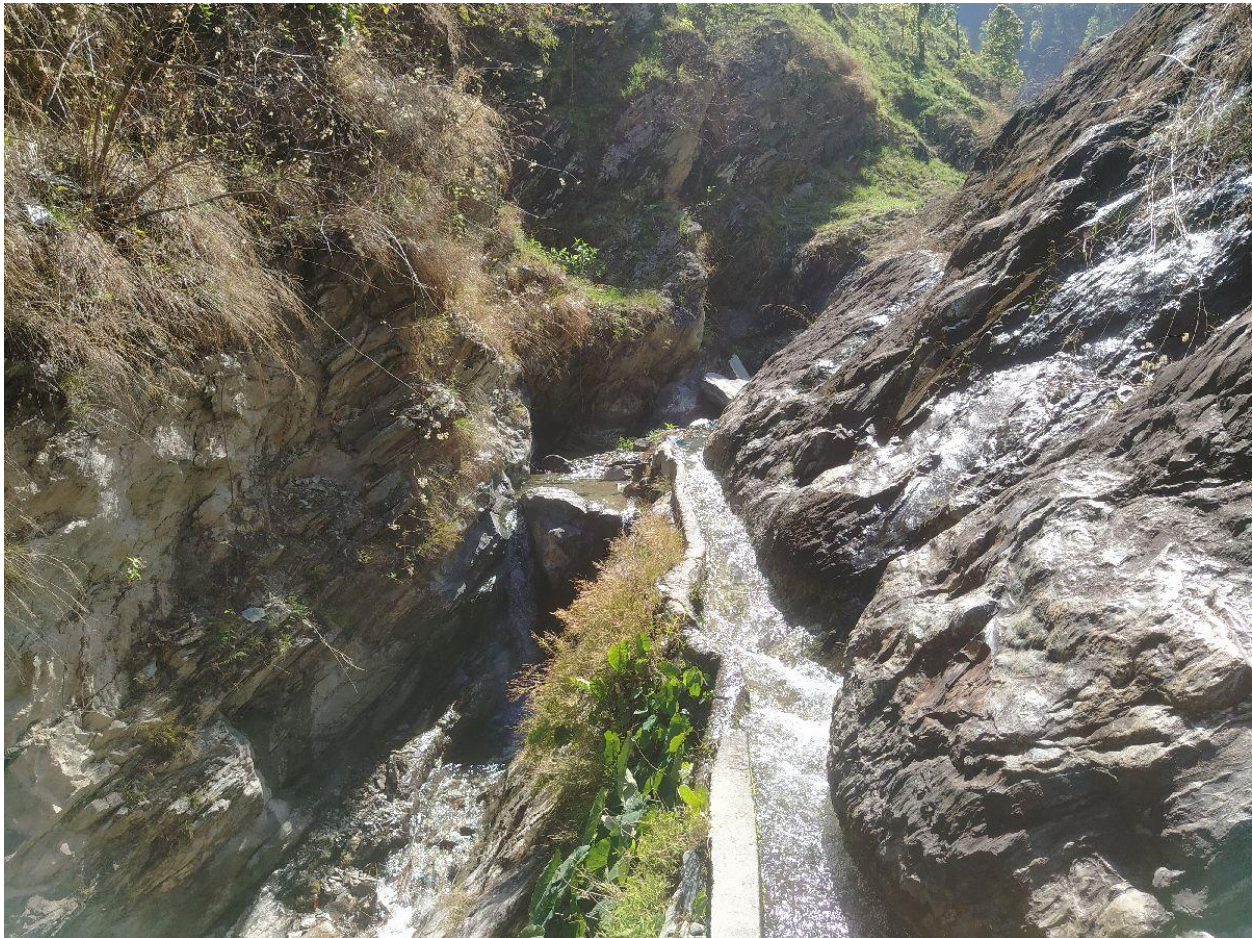
There is Bank erosion problem along the banks of Andheri Khola.

*Annex Photo 11: Main canal in Andheri Rupse IS in Okhaldhunga.*

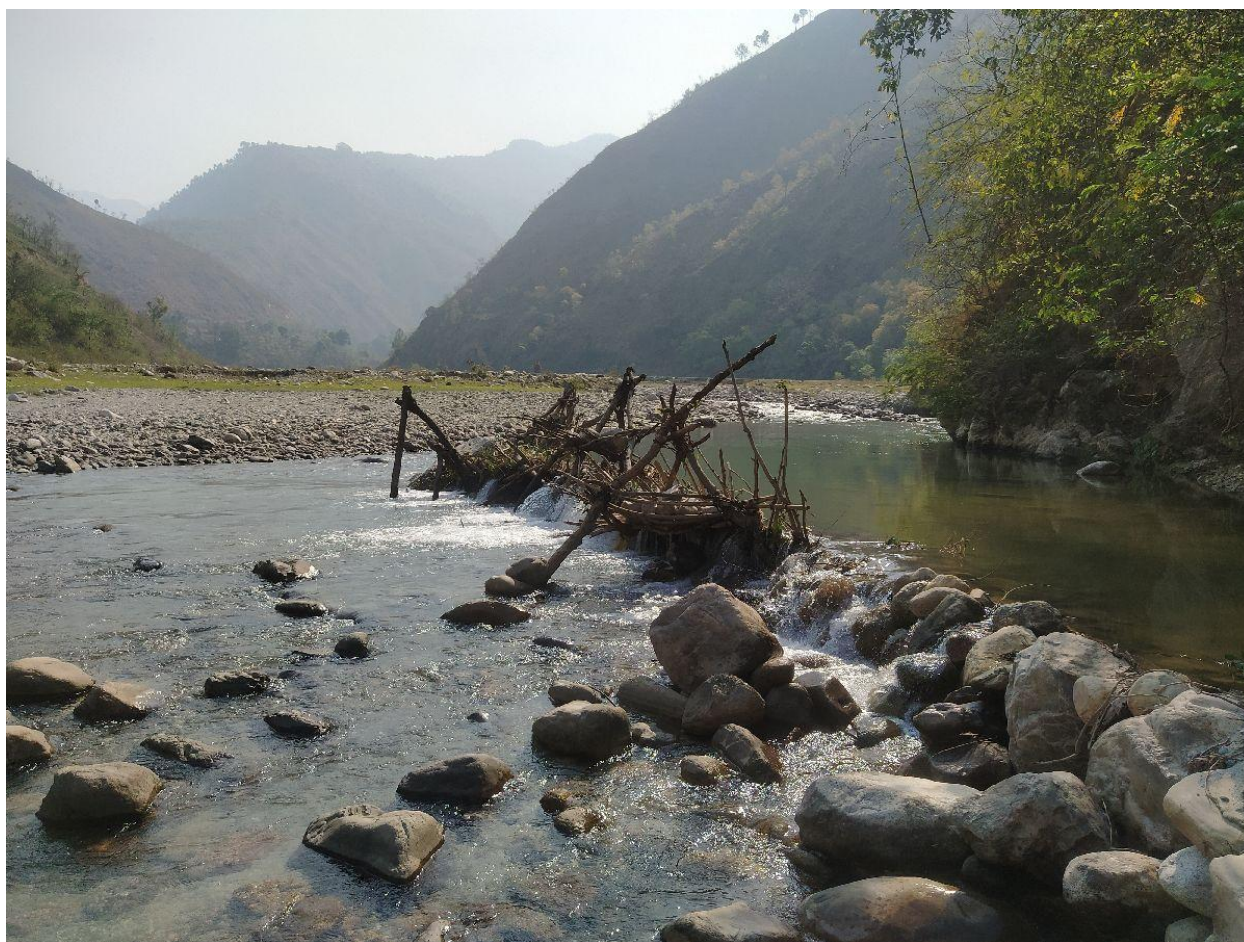
*Annex Photo 12: Temporary diversion from the river to intake in Kabre Mahabir Sichai Yojana IS in Okhaldhunga.*

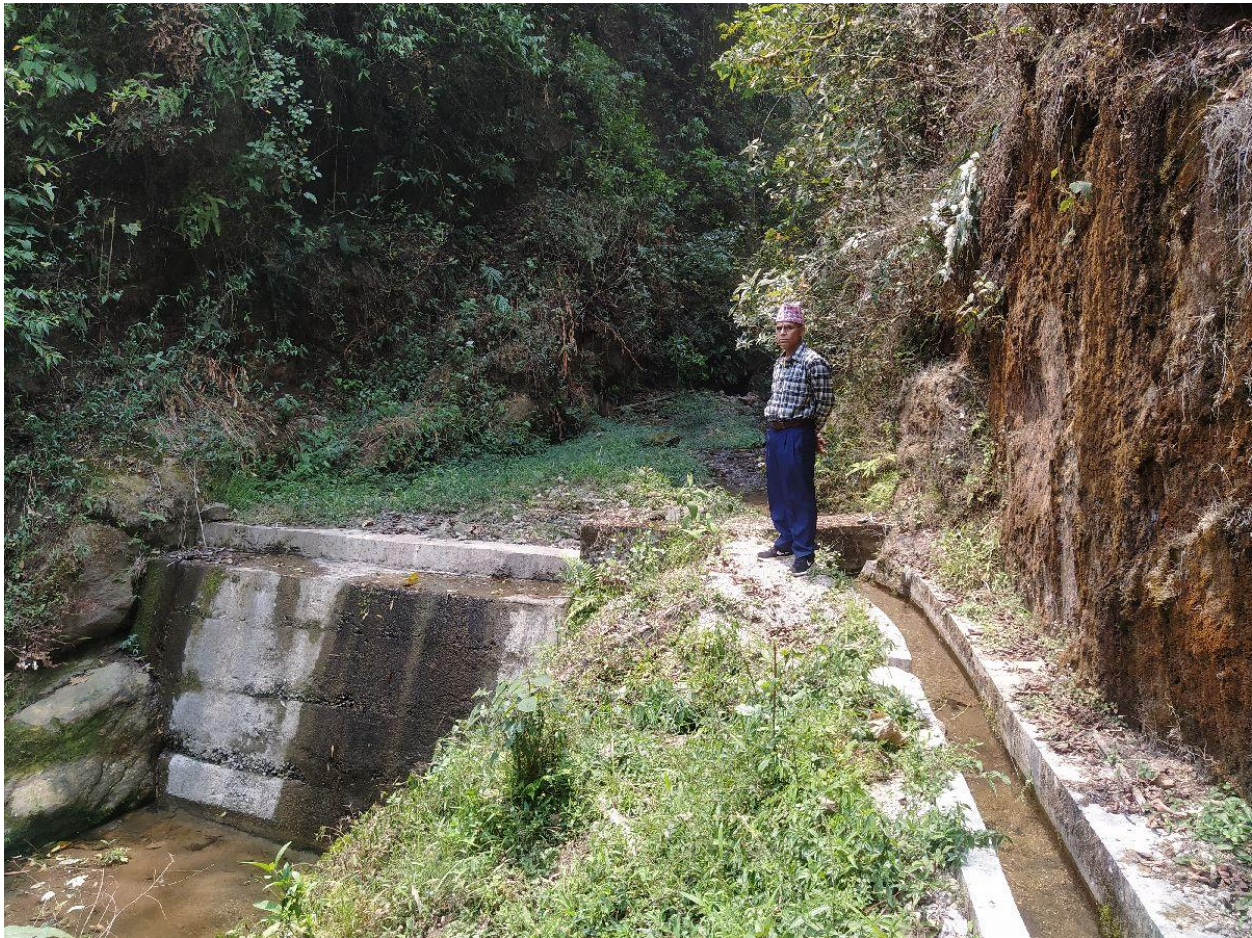
*Annex Photo 13: Intake of Saanimai Kharibote Sana Sinchai IS in Ilam.*

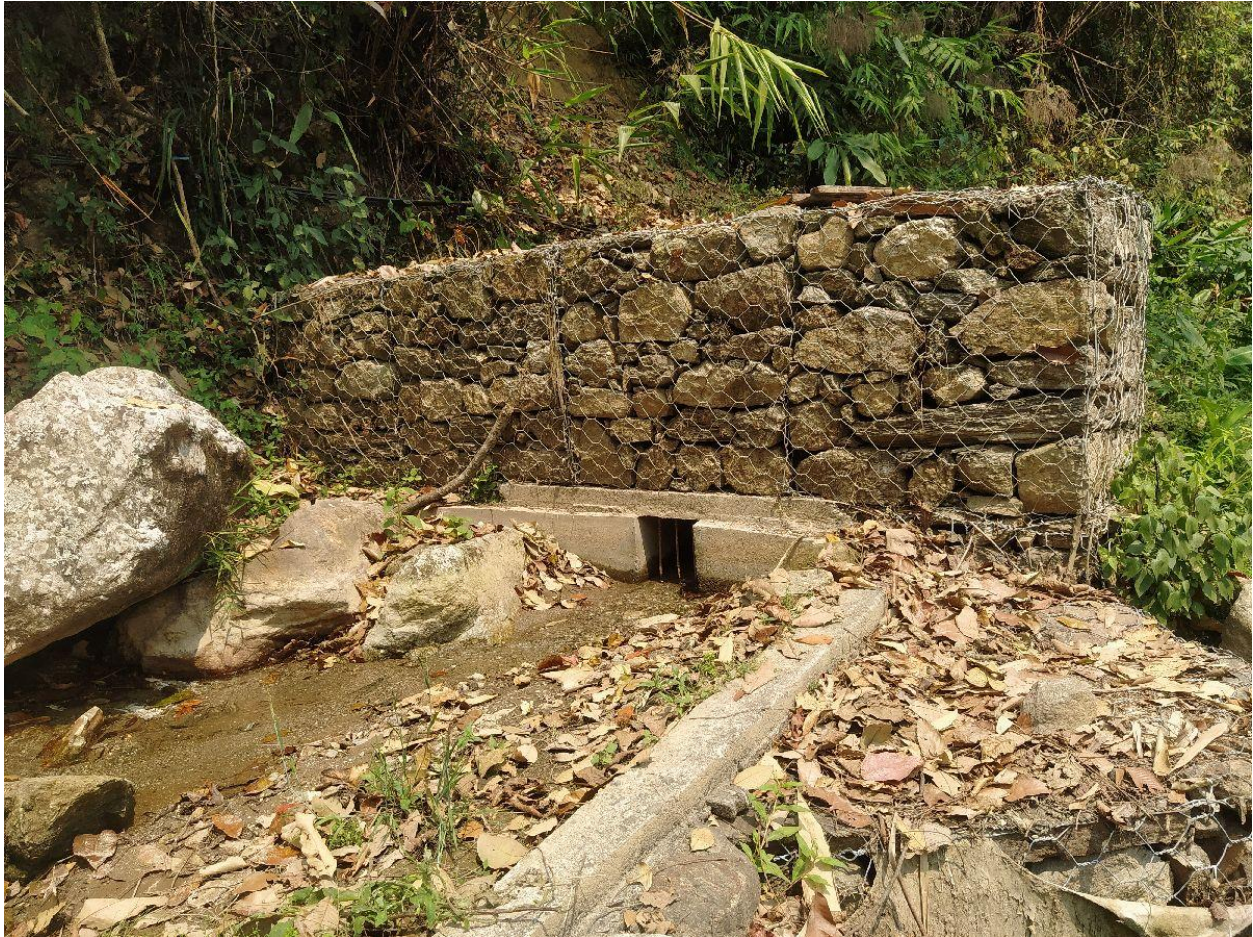
Annex Photo 14: Intake of Lewak Tole IS in Ilam District.

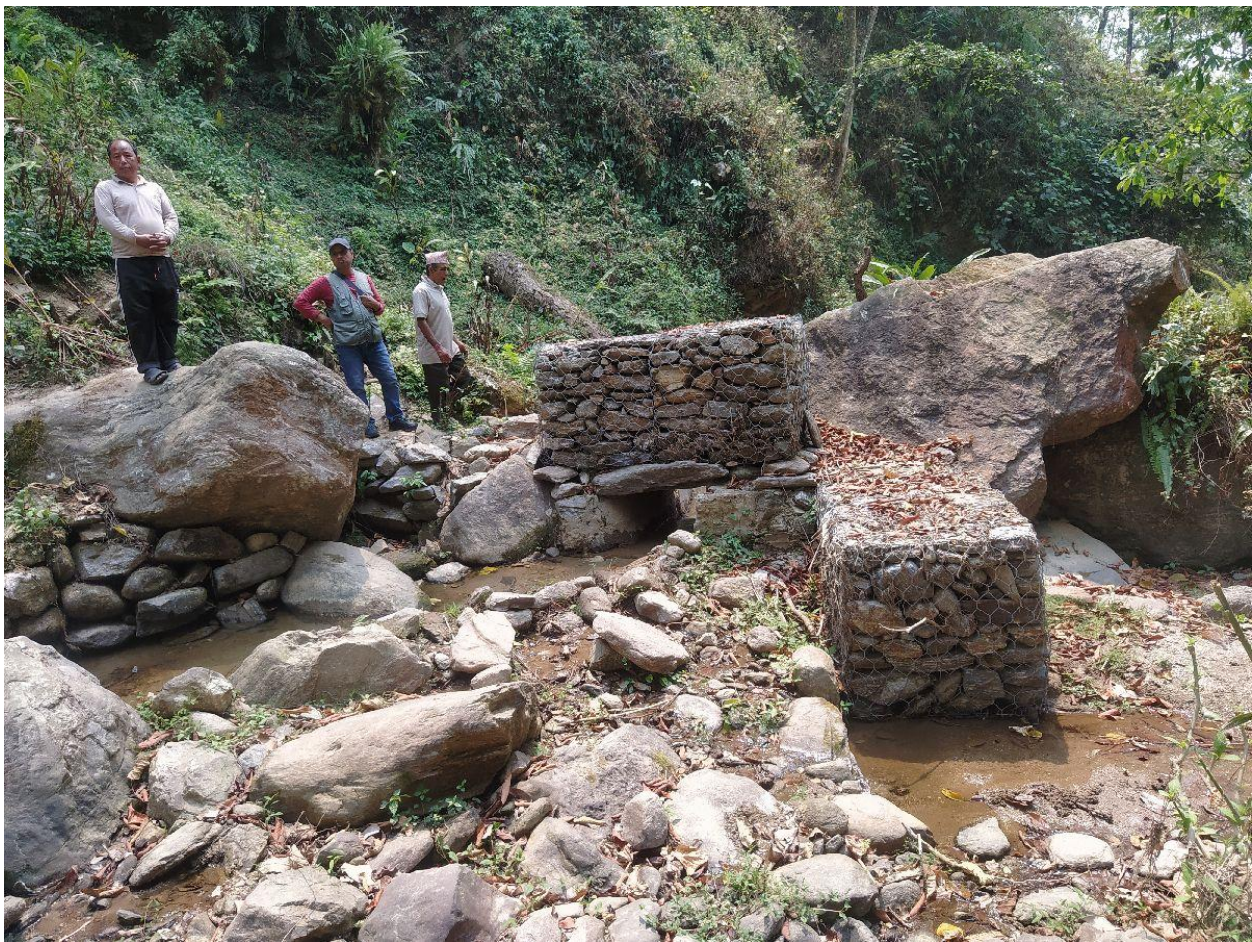
There is landslide problem along the canal alignment. Farmers feel that source is gradually getting dry in a period of last 10 years.

*Annex Photo 15: Intake of Khung Khola Titriya Sejepa Phewadin IS in Panchthar.*
